Fountain-Hyperion Collision Analysis

Updated with 2018 and 2019 data

Prepared for the Hyperion Street Safety Coalition

October 19th, 2021

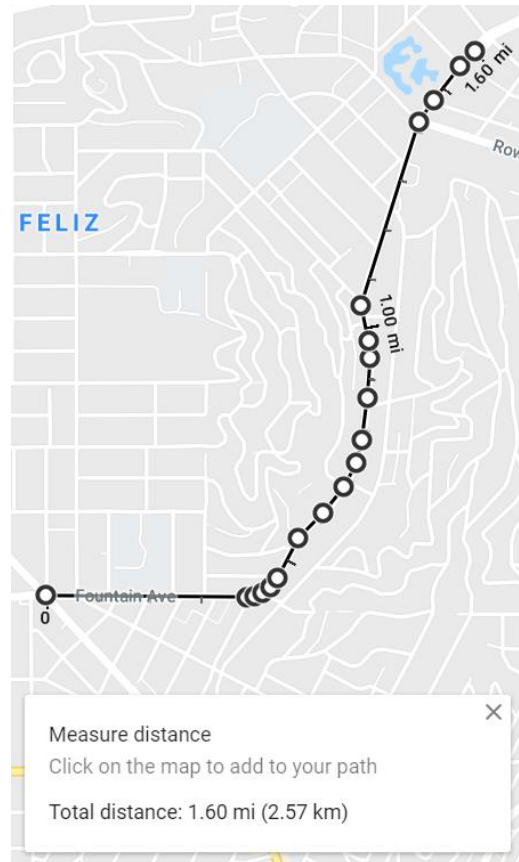
Analysis was conducted along the 1.6 mile stretch from Fountain/Hoover to Hyperion/Ettrick

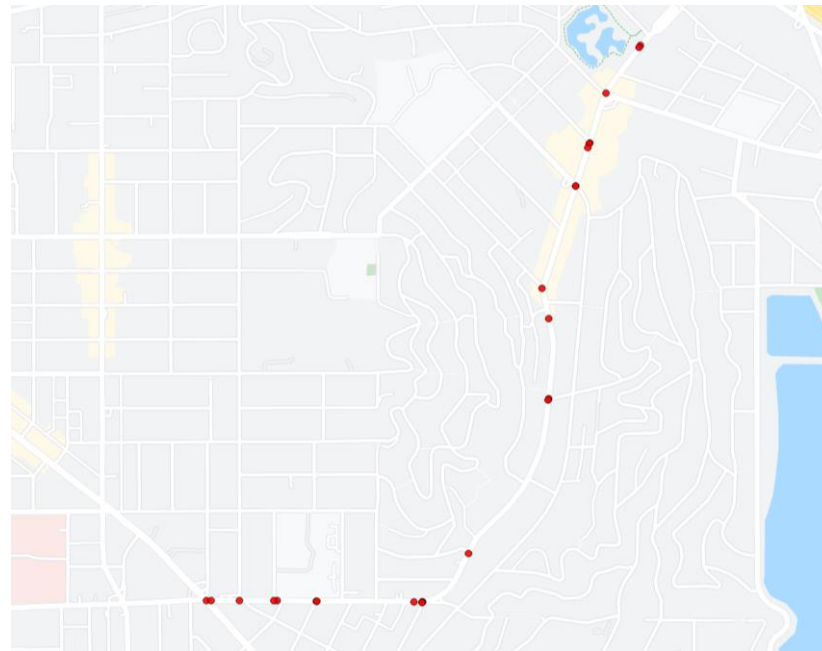
Fountain/Hyperion pedestrian collision points
2009-2019

From 2009 to 2019 there were a total of 24 collisions involving pedestrians

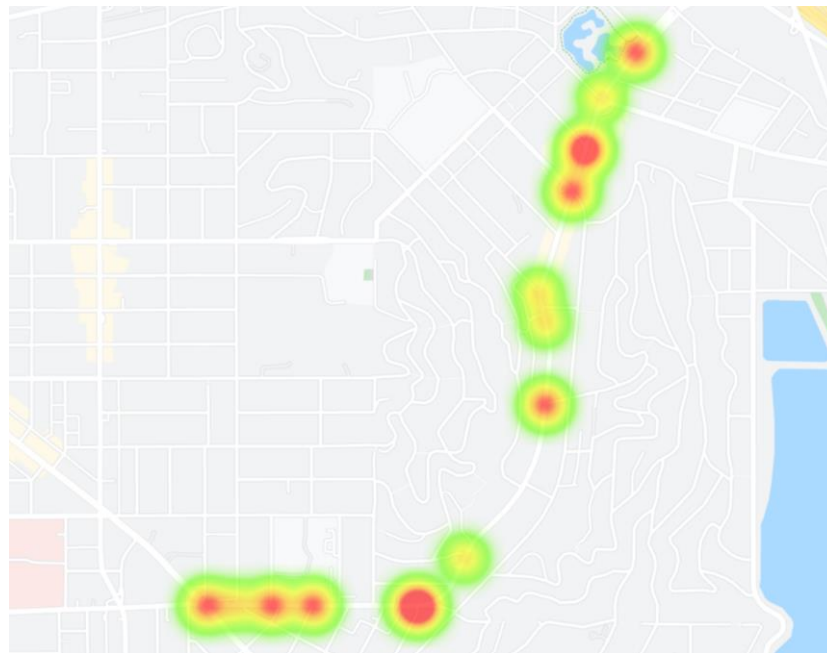
Fountain/Hyperion pedestrian collision heat map
2009-2019

Collisions involving pedestrians largely occurred at intersections, particularly Fountain and Hyperion

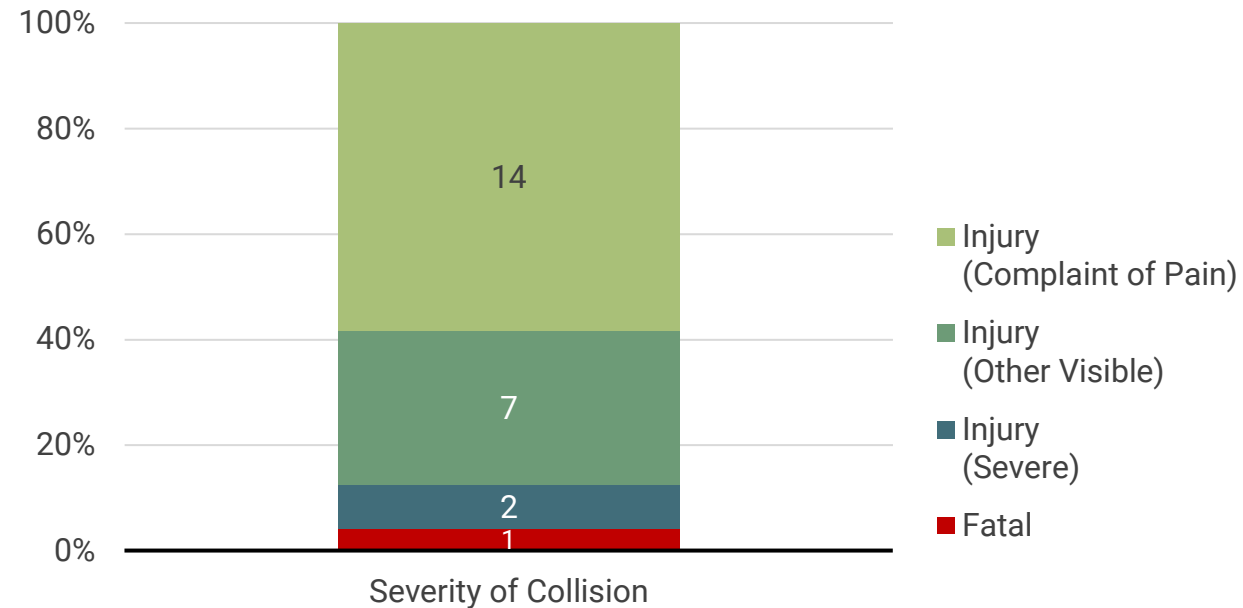
Severity of collisions involving pedestrians
2009-2019

100% of collisions involving pedestrians resulted in injury or death

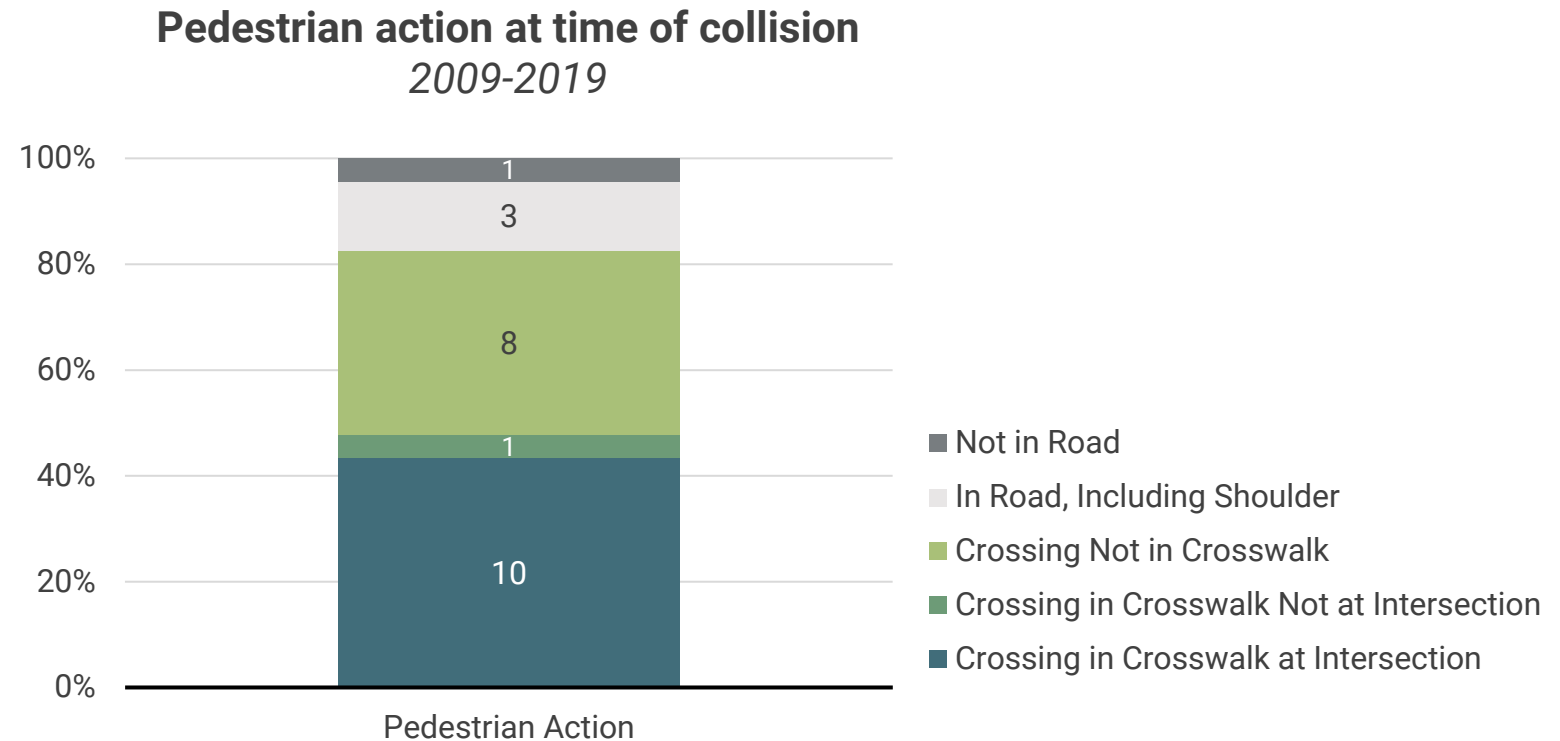
The majority of pedestrians were struck while crossing the street

These findings highlight the importance of adding crosswalks and improving existing crosswalks

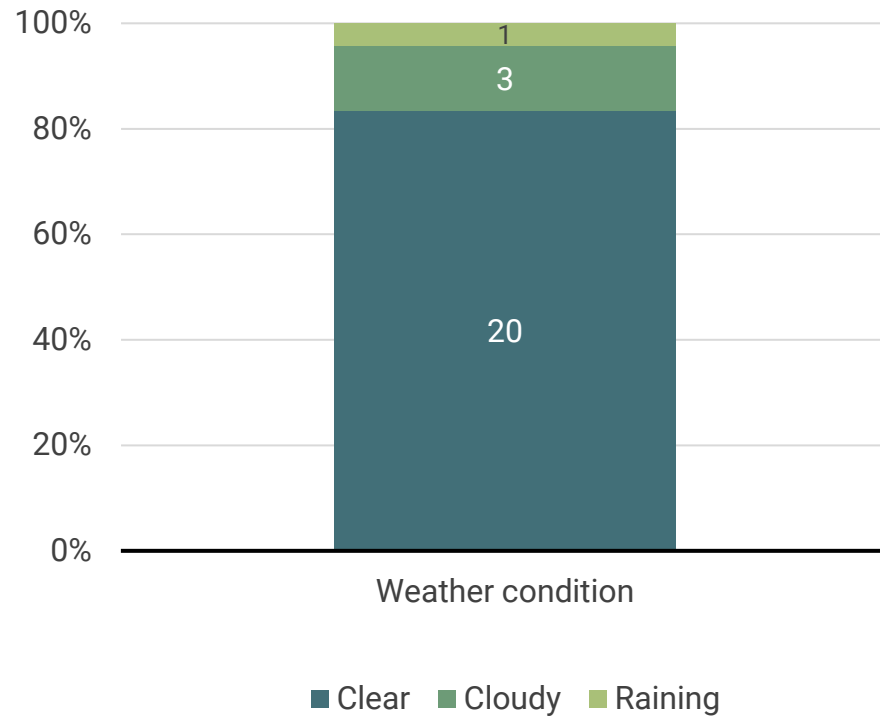
Weather conditions in collisions involving pedestrians
2009-2019

The majority of car collisions involving pedestrians occurred on clear days and in daylight

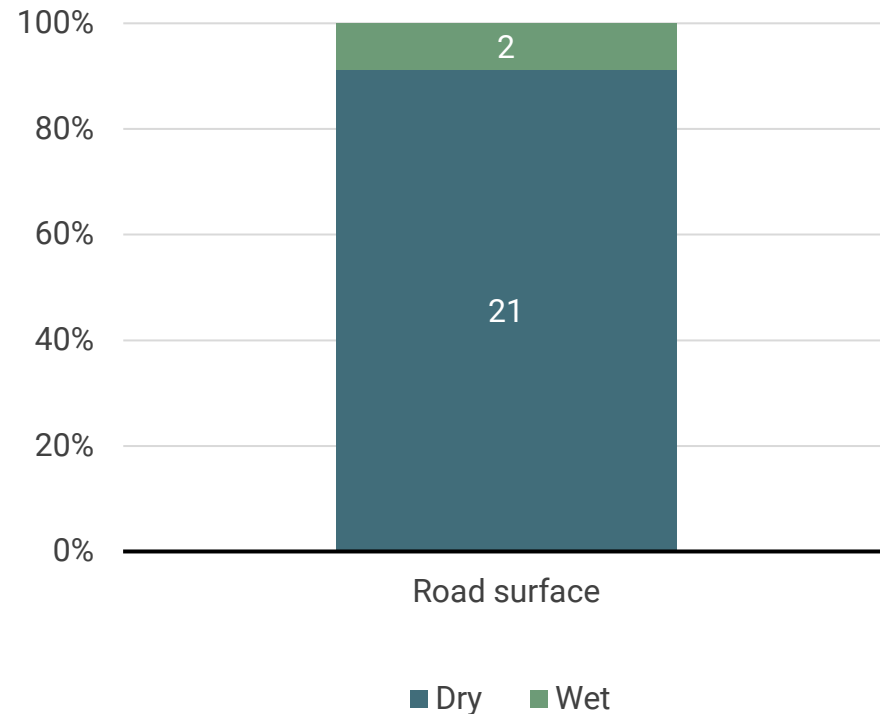
Road surface in collisions involving pedestrians
2009-2019

The majority of car collisions involving pedestrians occurred on dry roads with no unusual conditions

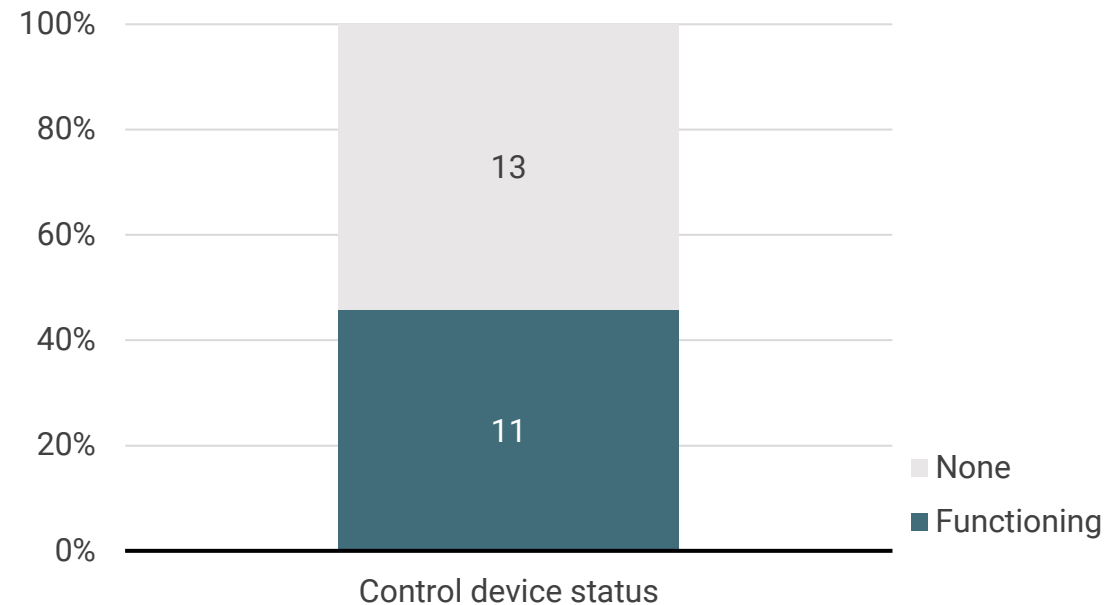
Status of control device in collisions involving pedestrians
2009-2019

In more than half of collisions involving pedestrians there was no control device present

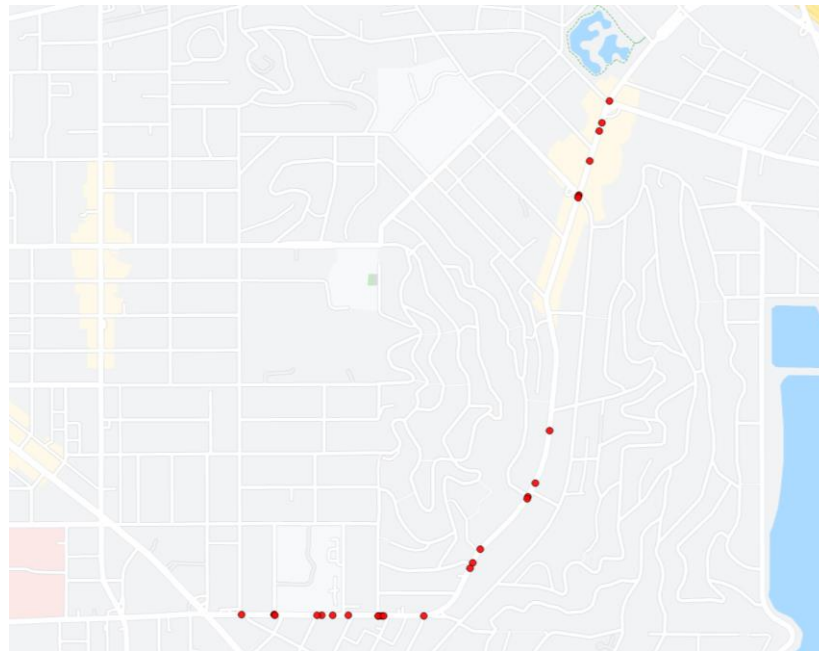
Fountain/Hyperion cyclist collision points
2009-2019

From 2009 to 2019 there were a total of 27 collisions involving cyclists

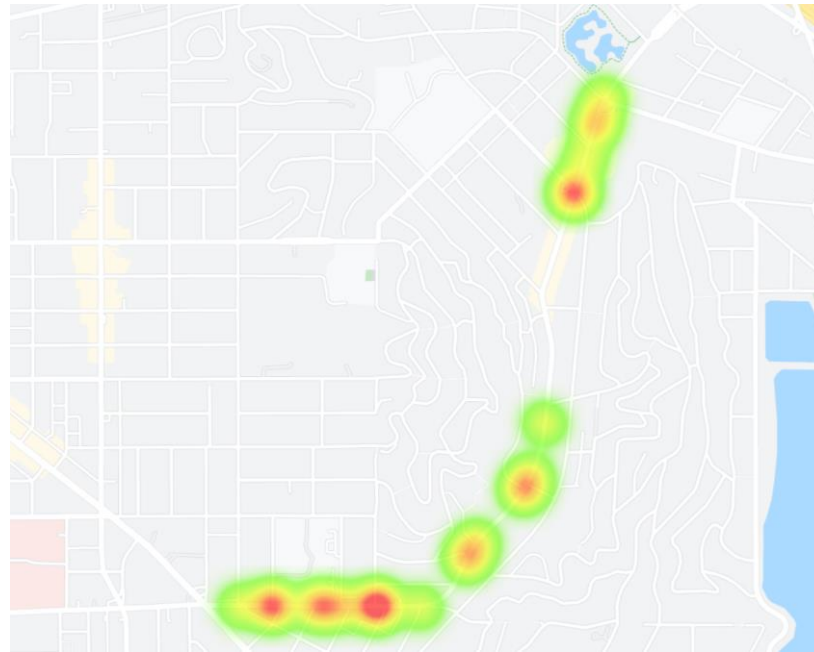
Fountain/Hyperion cyclist collision heat map
2009-2019

Car collisions involving cyclists most frequently occur along the Fountain section of the road

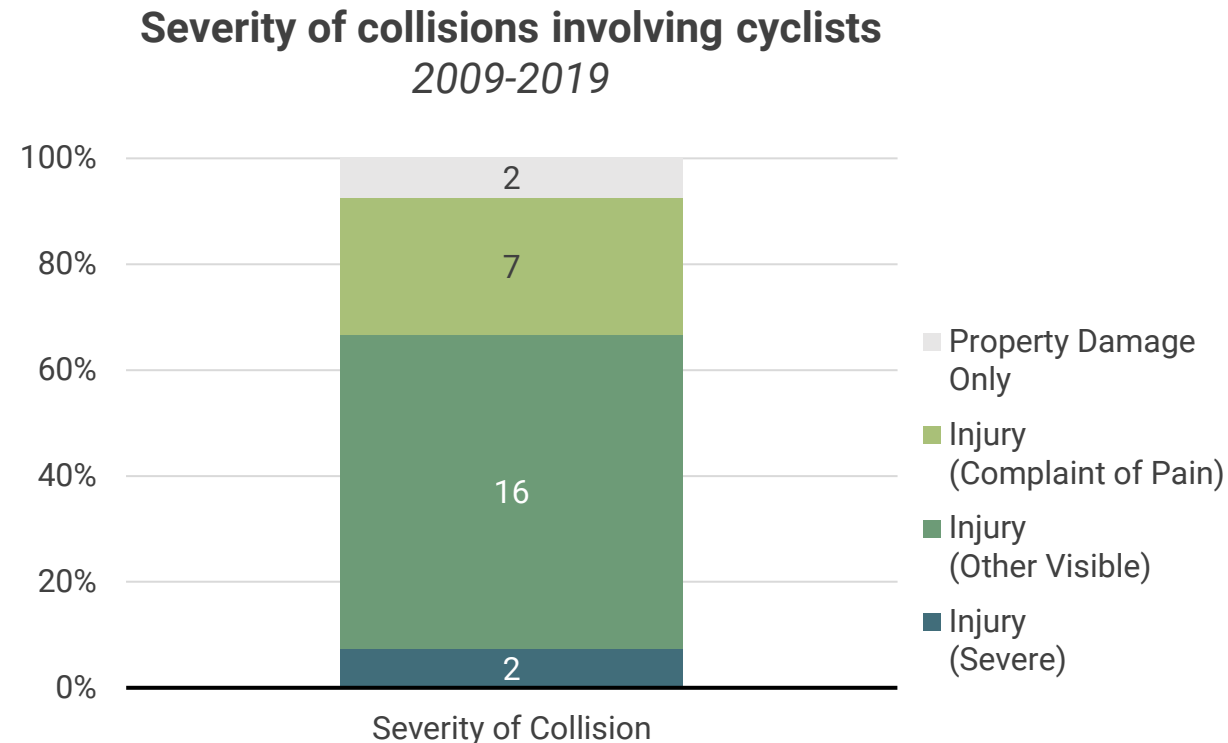
Collisions involving cyclists resulted in higher rates of visible injuries than collisions with pedestrians

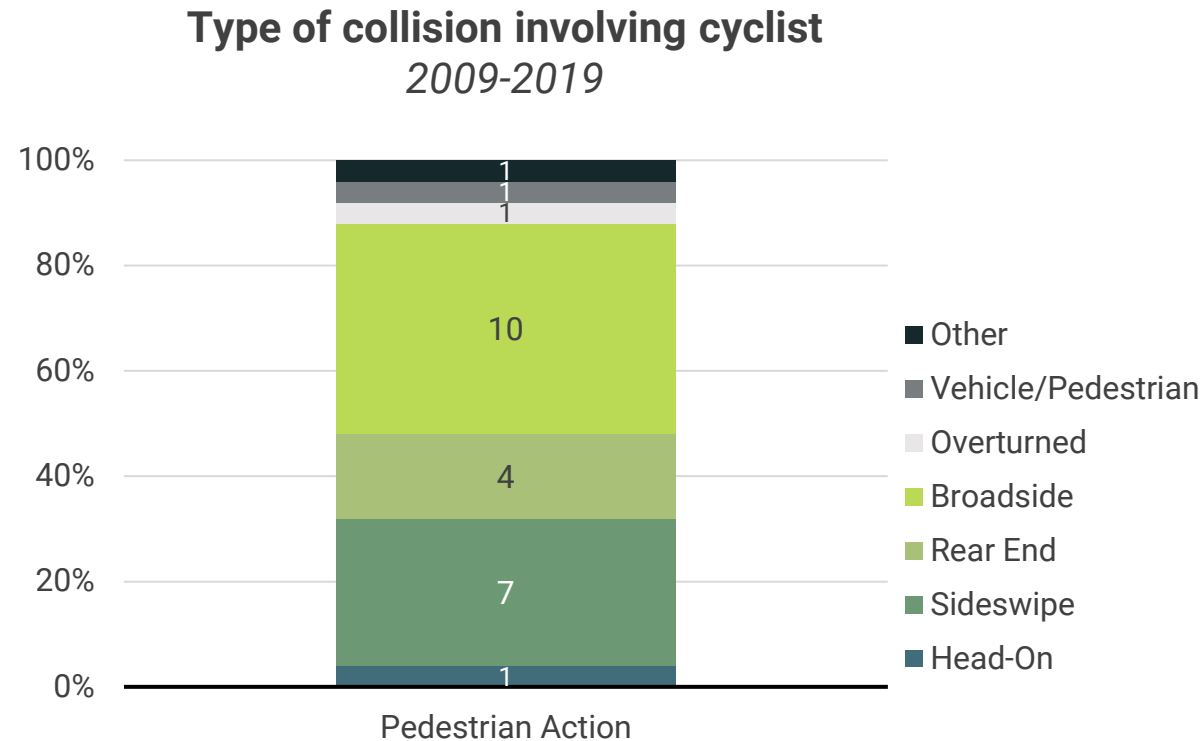
The majority of cyclists were broadsided, and a significant number were rear-ended or sideswiped

These findings suggest that cyclists are being hit by cars making turns, or cars coming up too fast behind them

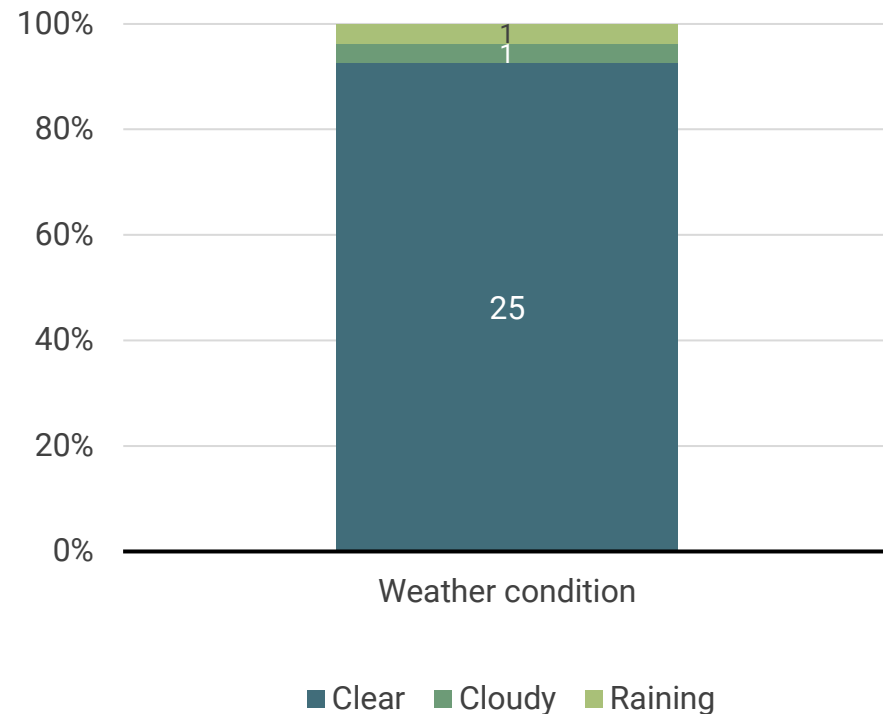
Weather conditions in collisions involving cyclists
2009-2019

The majority of car collisions involving cyclists occurred on clear days and in daylight

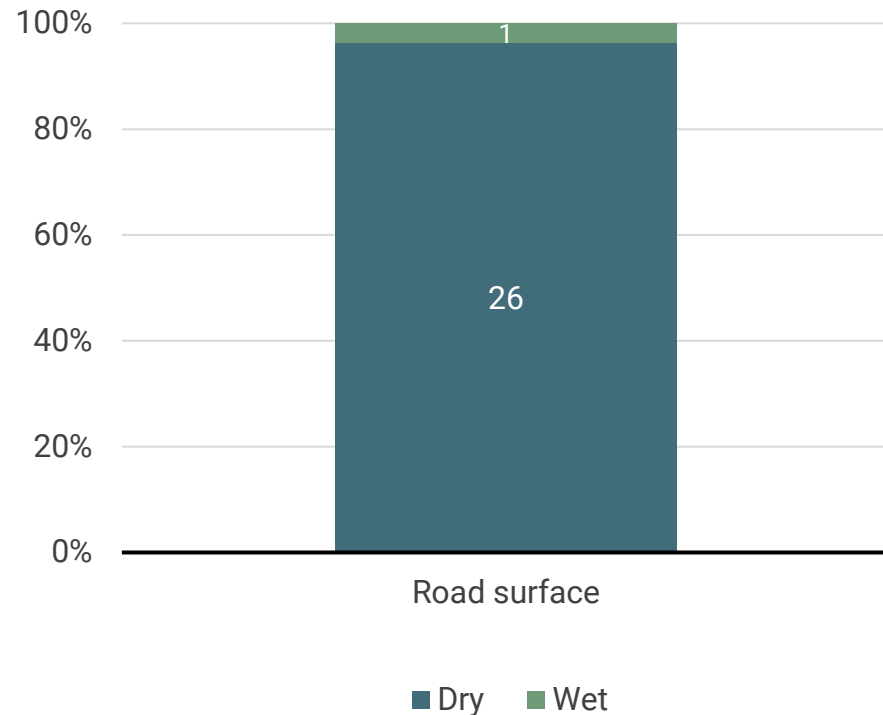
Road surface in collisions involving cyclists
2009-2019

The majority of car collisions involving cyclists occurred on dry roads with no unusual conditions

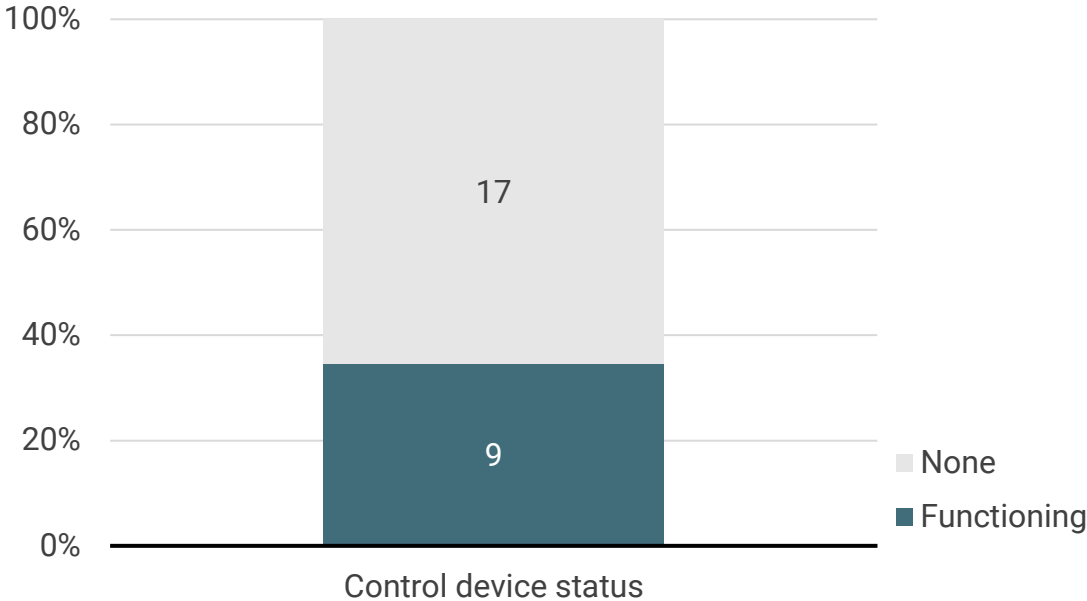
Status of control device in collisions involving cyclists
2009-2019

In the majority of car collisions involving cyclists there was no control device present

Note: one collision involving cyclists did not include data on status of control device
